## DISTRICT 2 – COAL MINE NEAR MISS

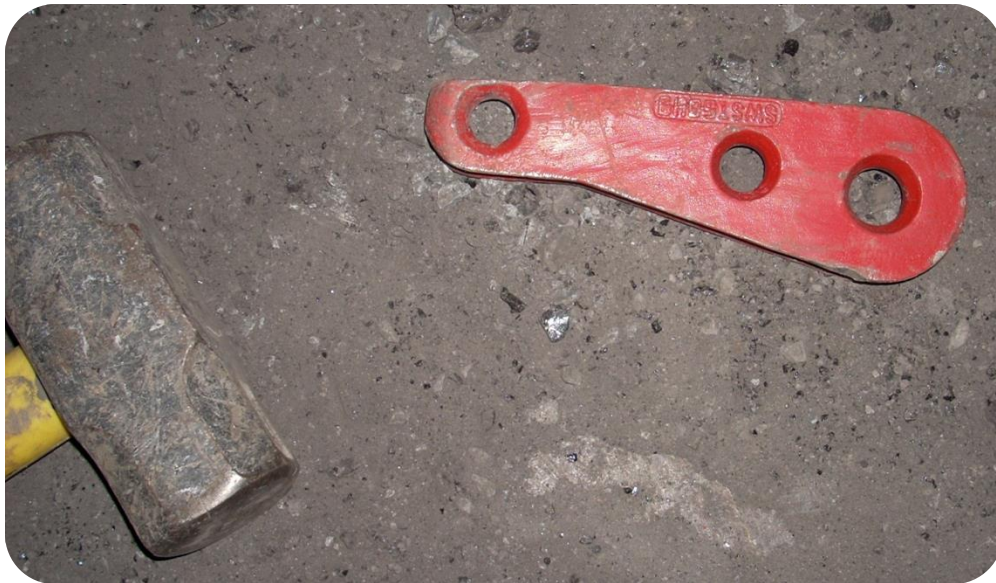
On January 9, 2016 a non-fatal accident occurred when a beltman was struck by a metal wedge. The victim was observing conveyor belting being pulled onto belt structure by a wire rope attached to a battery powered scoop when the accident occurred. As the scoop began pulling the conveyor belt, the cable connection caught on the belt structure causing tension on the wire rope. The increased tension on the undersized wire rope pulled it through the socket/wedge connector causing the wedge to become a 2 pound projectile. The wedge travelled approximately 31 feet and struck the victim in the cheek resulting in fractured bones and facial lacerations.

- Use proper sized components for all tool assemblies.
- Train miners and supervisors to use proper procedures and tools.
- Use tools only for their proper application.
- Place your body clear of failure hazards when towing or pulling with wire rope.
- Before performing any job, consider all hazards and implement formal procedures that address possible hazards.
